V-GRASP Images and Rainfall Data

The V-GRASP project is a long-running (1988-2013) activity of the *Scientific Expedition Group* (SEG) that is being conducted in the Gammon Ranges of South Australia. The continuing activities that make up the V-GRASP project are:

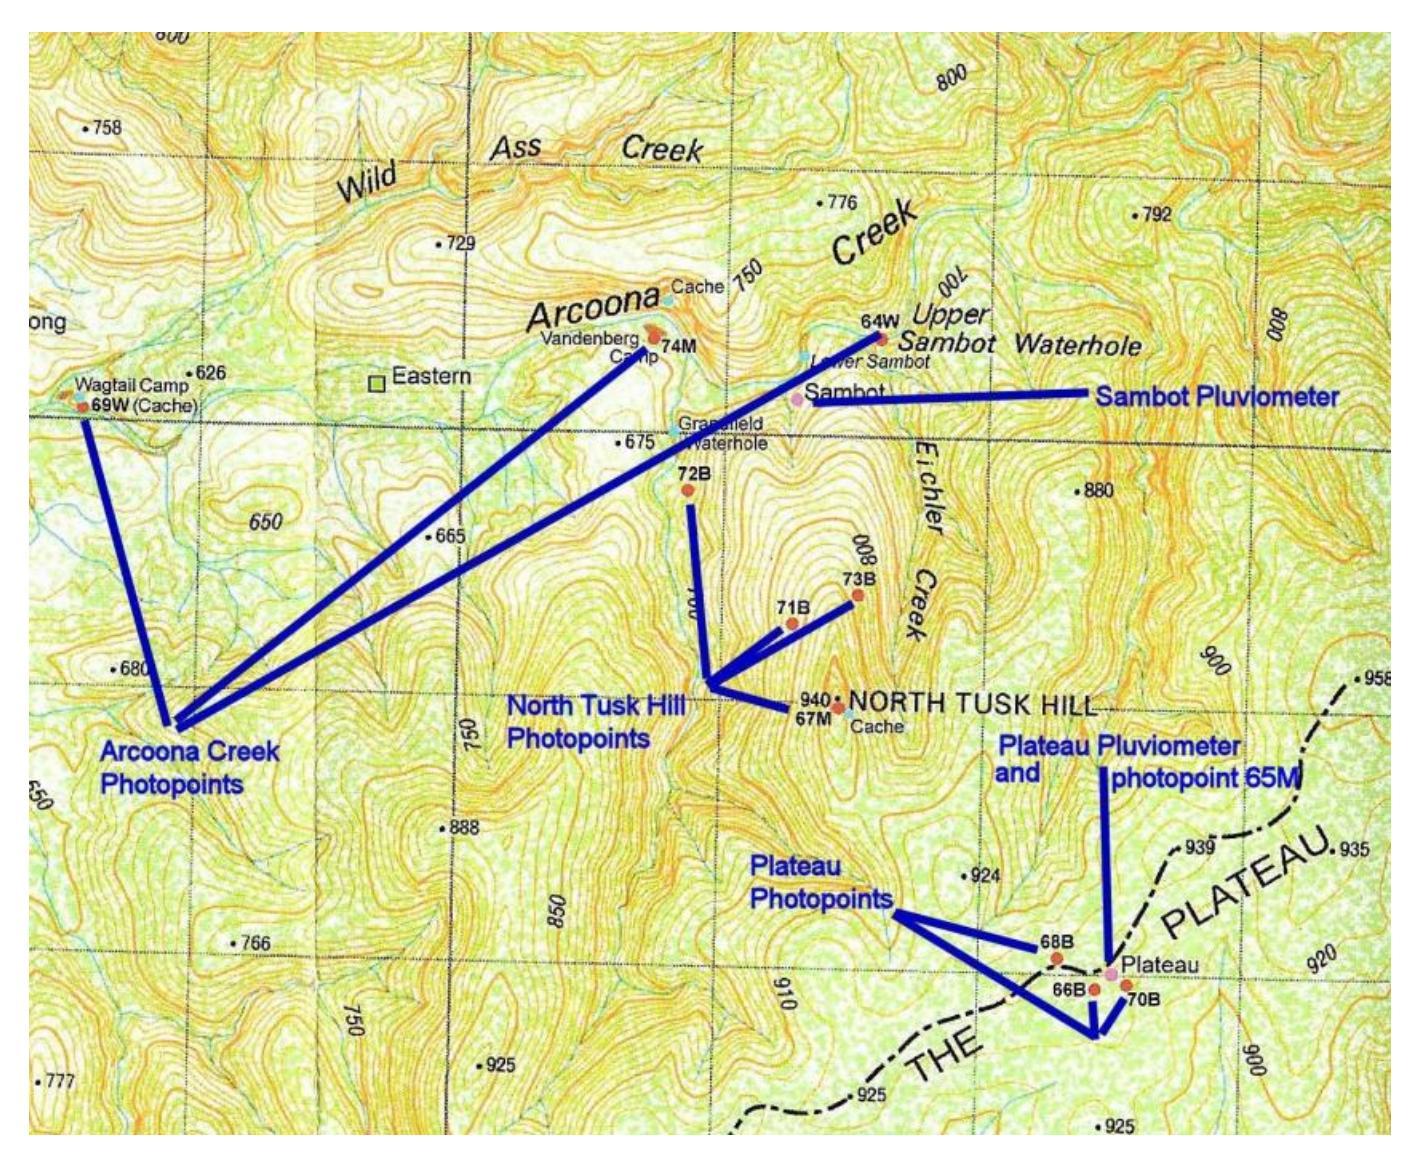
This report describes some relationships seen when the photographic record of changes occurring at photopoints was compared with the rainfall data collected around the same time. The project area over which the comparison has been made is shown in the map with the locations of all photopoints shown and the locations of the two pluviometers that supplied the rainfall data also shown (Sambot pluviometer and Plateau pluviometer).

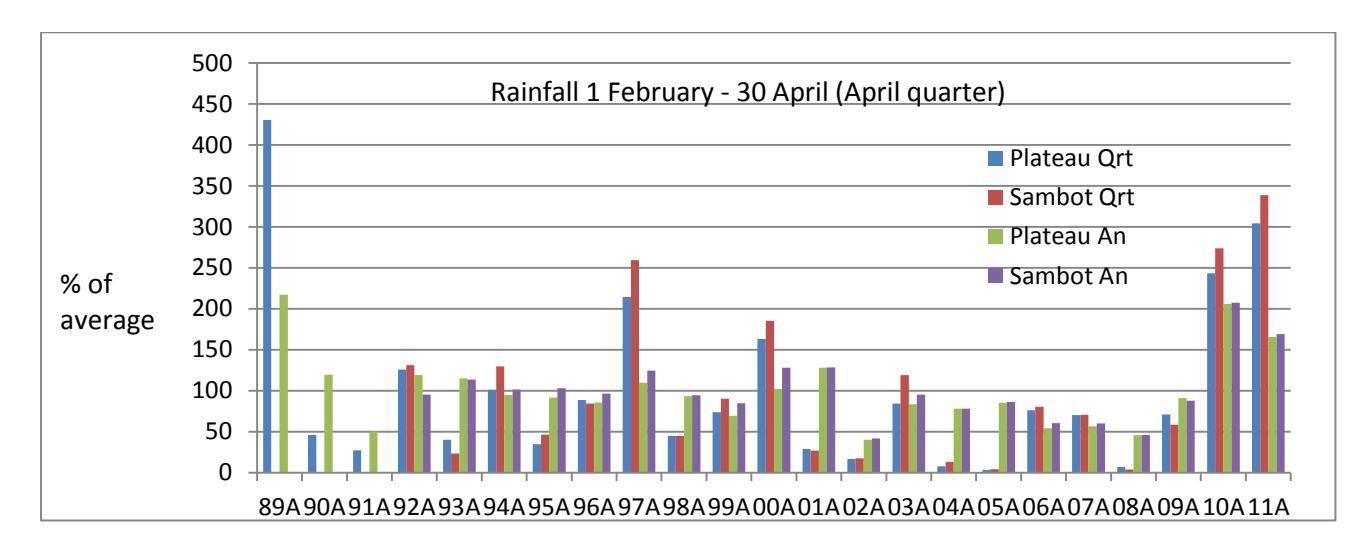
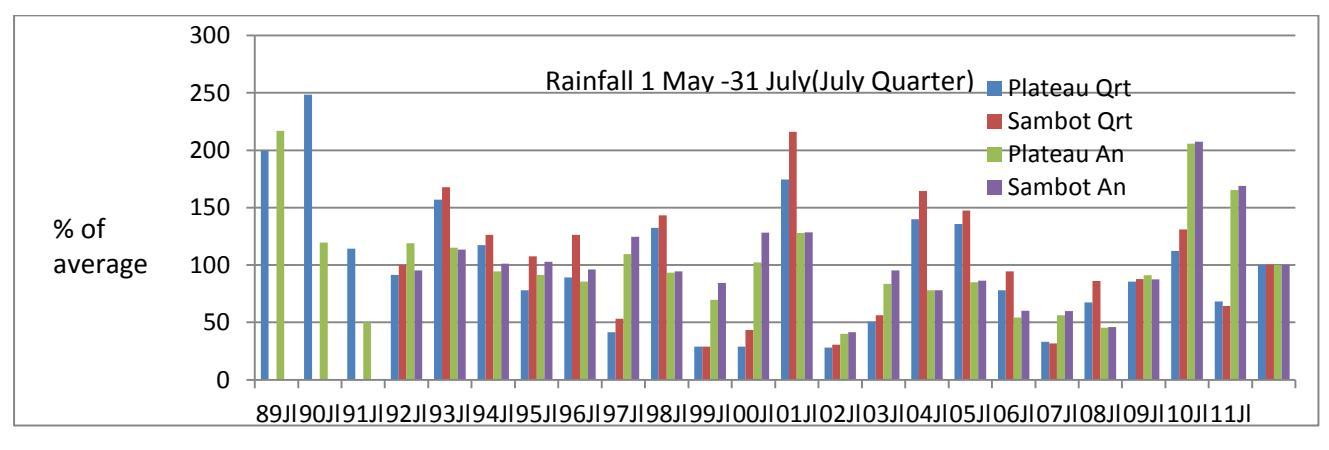
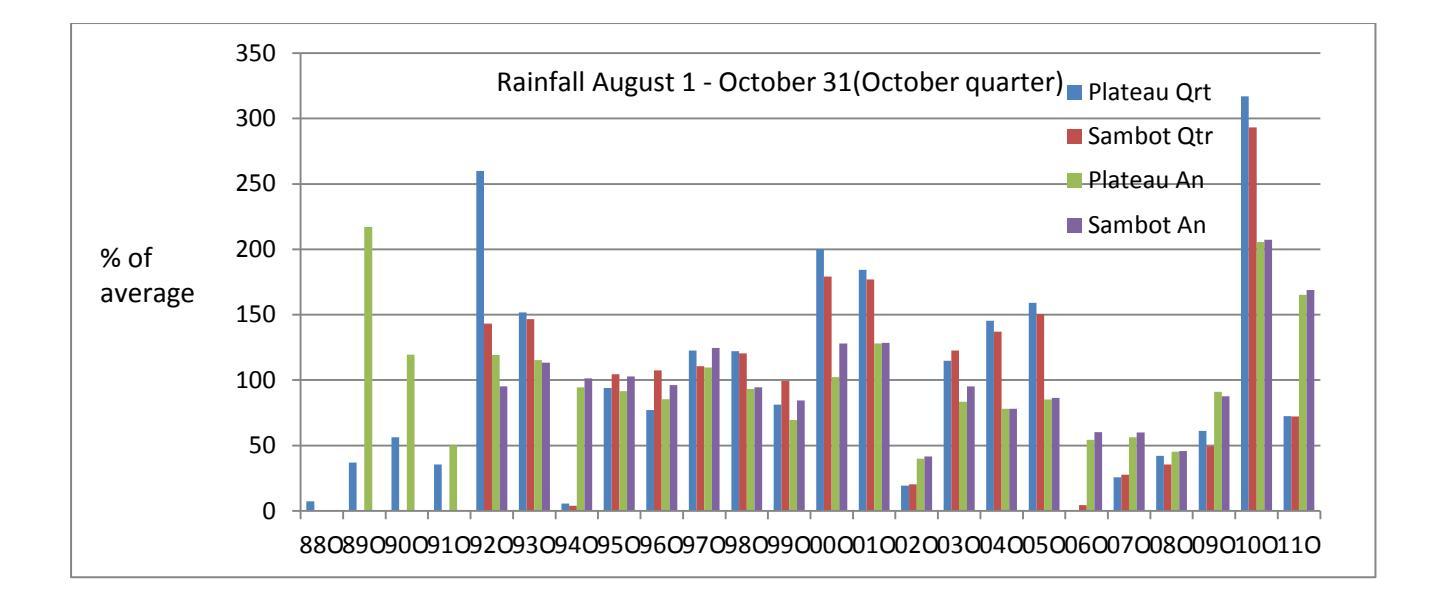
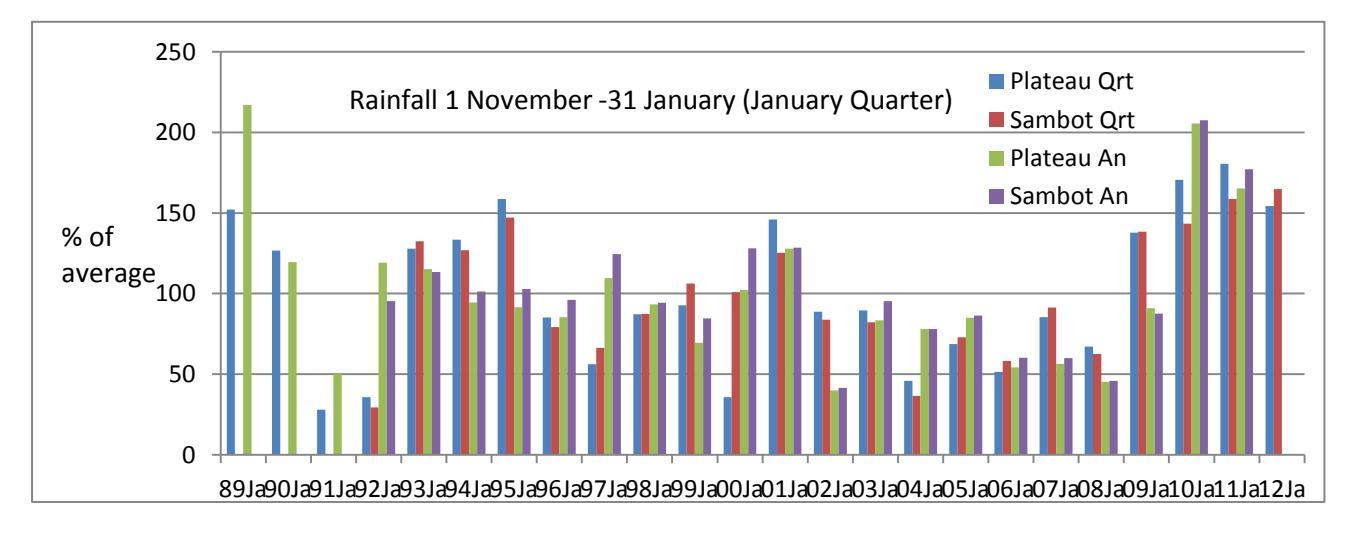
Rainfall 1989-2011(Plateau and Sambot Pluviometers)

The four charts below display rainfall data collected by the Plateau and Sambot pluviometers since 1989 for the Plateau and since 1992 for Sambot. Each chart displays rainfall for three month (quarterly) and 12 month (annual) periods. The 12 month period runs from 1 February in one year to 31 January in the next year. Photographs are now being taken in April and October each year and these have been common months for photography in past years. Another common month for photography in the past was July. Using the quarterly intervals as specified below sees many of the photographs being compared with rainfall in a 2-3 month period preceding the photograph. This was assumed to be an appropriate relationship between photographs and rainfall.

The raw rainfall figures of mm have been converted to percentages for display in the charts. These are percentages of the rainfall averaged over the entire period that the pluviometers have been operating. For example in the chart for the April quarter the two bars at the far left represent rainfall recorded at the Plateau pluviometer in the period 1 February 1989 to 31 January 1990 and this interval is labelled as the 89A interval. The blue bar is the rainfall for the April quarter of 1989 only expressed as a percentage of the average for all April quarters. This was about 430% so that in April 1989 more than four times the average rainfall for all April quarters was recorded. The green bar is the rainfall for the entire twelve month interval (89A). This was about 210% of the average for all of the twelve month periods making up the time for which the Plateau pluviometer has been operating.

- 1. The years 2006-2008 are the lowest rainfall years for any consecutive three years in the 1989-2011 interval. All three annual rainfalls were in the range 45-60% of the 22 year average. All quarterly rainfalls were in the range 4-94% of the 22 year average.

- 2. In 2009 the annual rainfalls were also below average but close (91% and 88%) and the January quarterly rainfalls were well above average.
- 3. In 2010 the annual rainfalls and all the quarterly rainfalls were well above average

- 4. In 2011 Annual rainfalls were well above average again with only the October quarterly rainfall being below average.
- In 2002 annual rainfall was less than 50% of average as were the quarterly rainfalls for April July and October. The rainfalls for the January quarter were 89% and 84% of average. So 2002 was a single bad year for rainfall

- 6. 1991 annual rainfall was 50% of average and only the July quarter was near average. So 1991 was another single bad year for rainfall.
- 7. 1989, the first year in which a full year's rainfall was collected at the Plateau Pluviometer was a good year for rainfall although the October quarter rainfall was only about 40% of average.

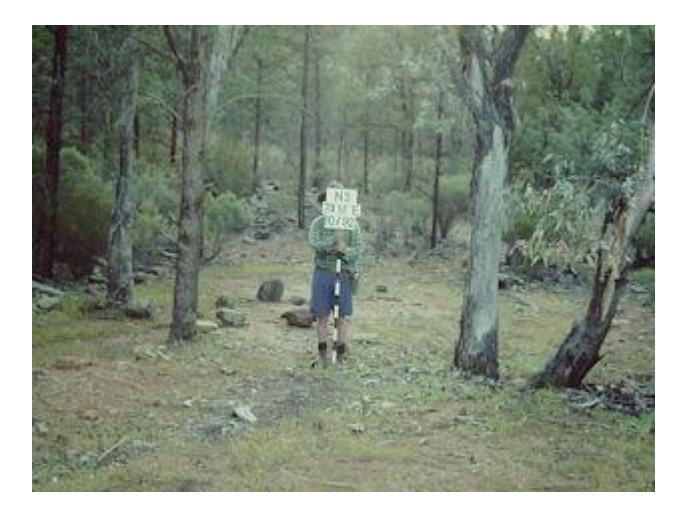
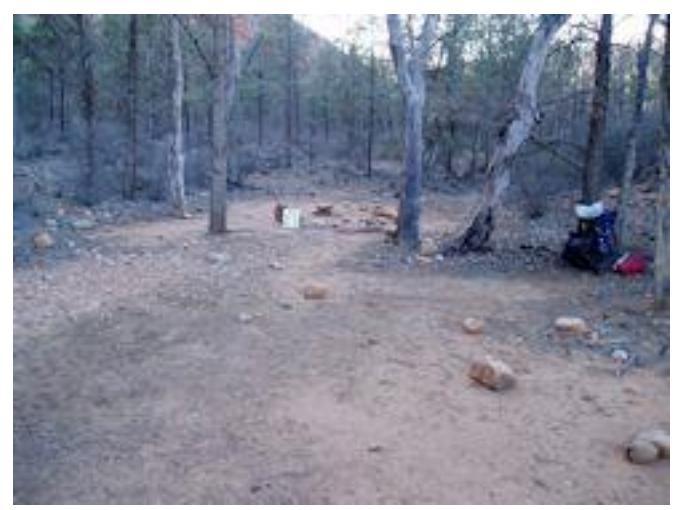
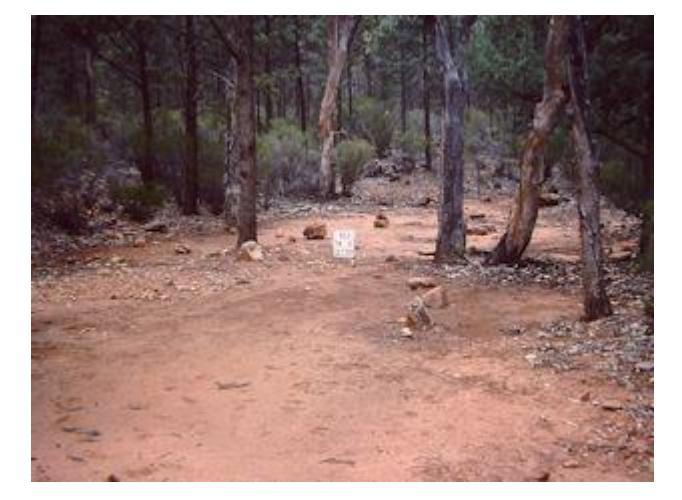
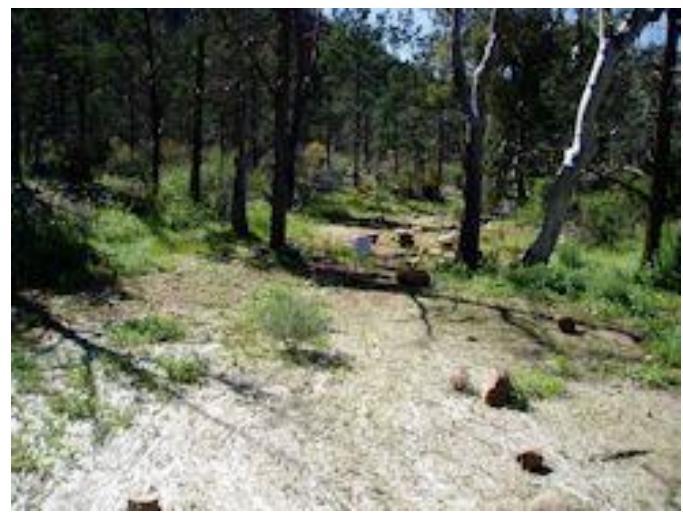
Site 74M: Van den Burg camp. The images are the easterly views. October 1992 is fairly close to the beginning of frequent camping by SEG groups. It shows a fairly uniform green tinge on the ground and quite a lot of litter. October 2010 shows more green growth than 1992 but there is an obvious lack of green and litter in the places where tents would have been regularly set up and where people would have been walking back and forth.

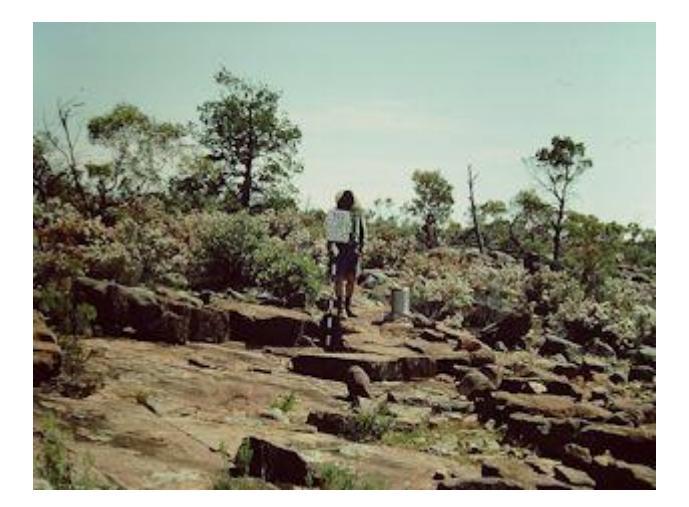
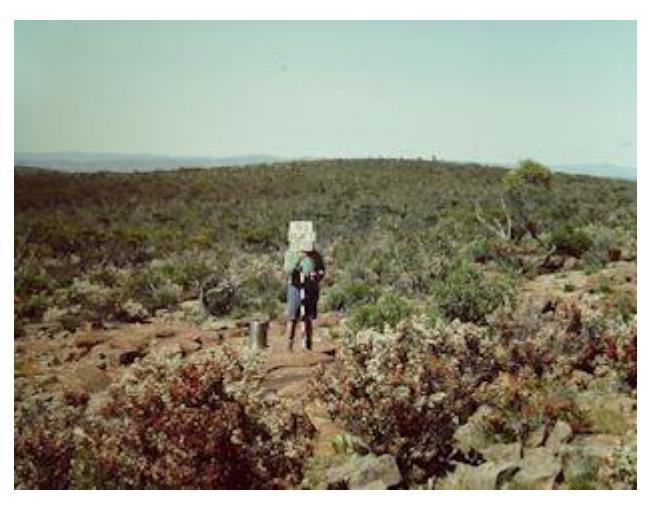
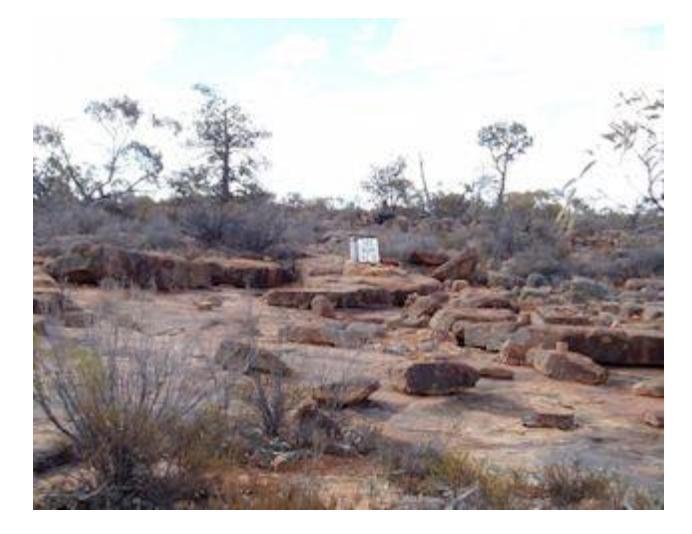
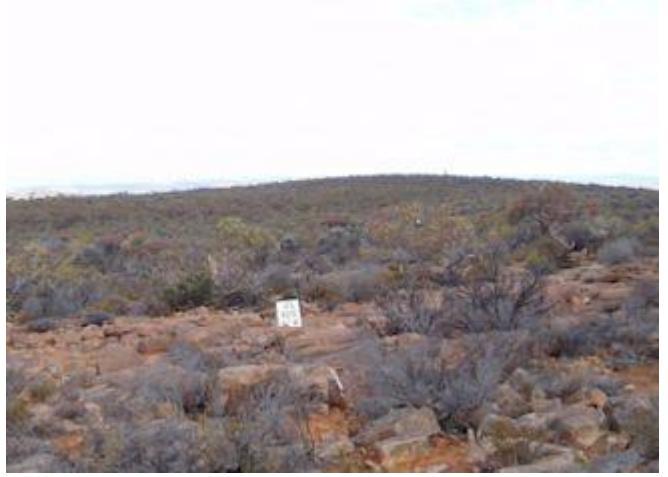
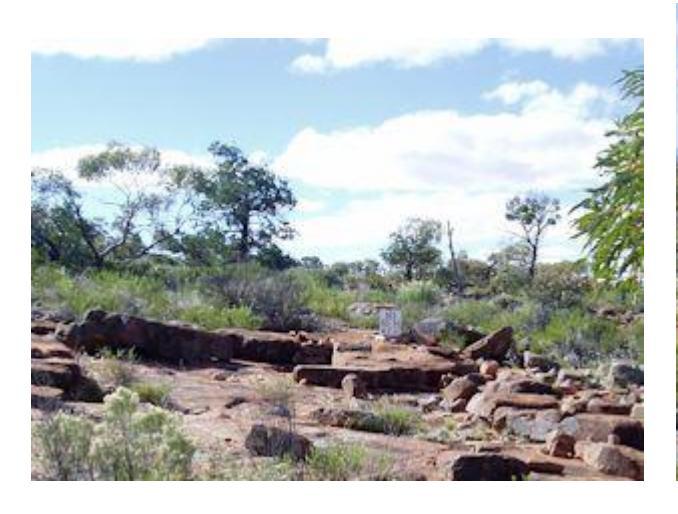
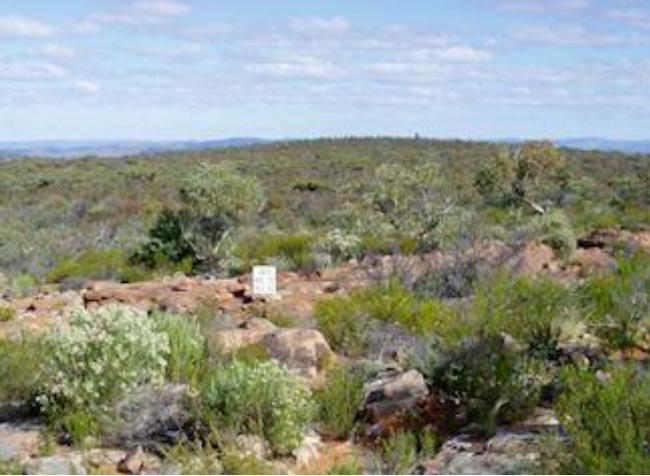
Site 65M: Plateau pluviometer. The north and south views show a dramatic drying out of vegetation in April 2008 compared to lush growth seen in October 1992 and again in April 2011. No evidence of human impact seen other than the pluviometer.

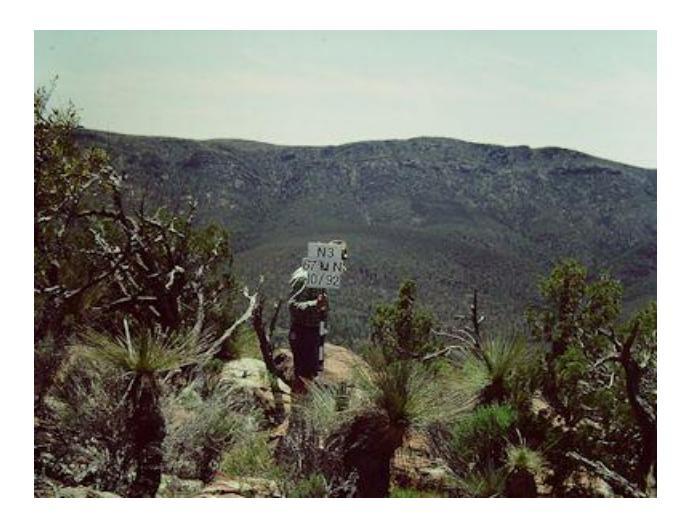
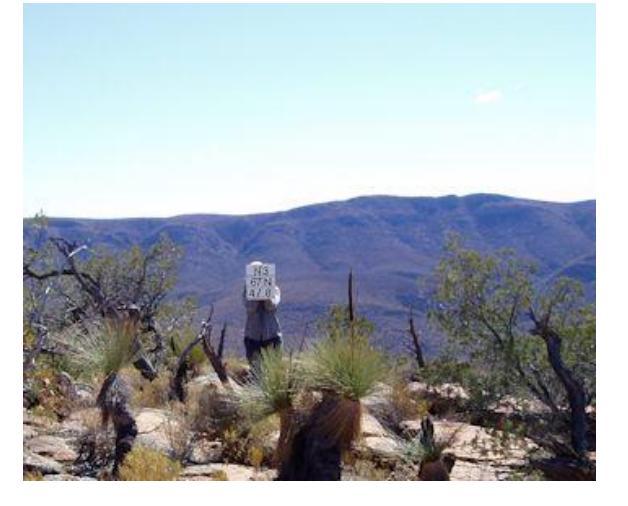
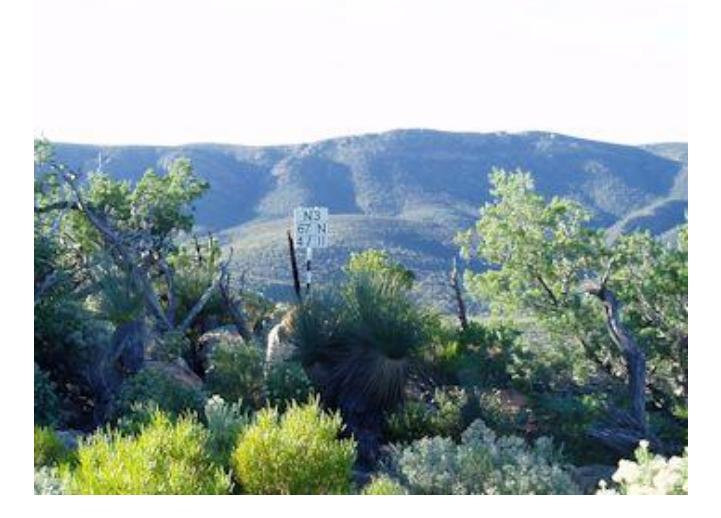
Site 67M: North tusk hill summit. The differences between 1992, 2008 and 2011 are not as striking as for site 65M but still substantial. The views shown are the northerly views and the differences are the most noticeable of the four different views taken. No evidence of human impact.

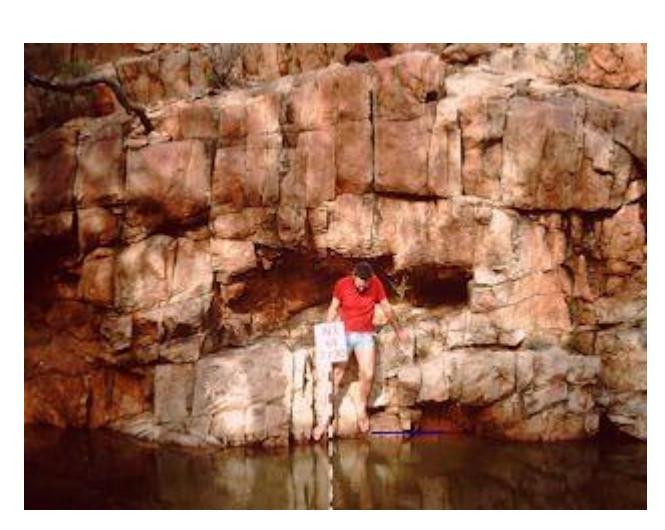
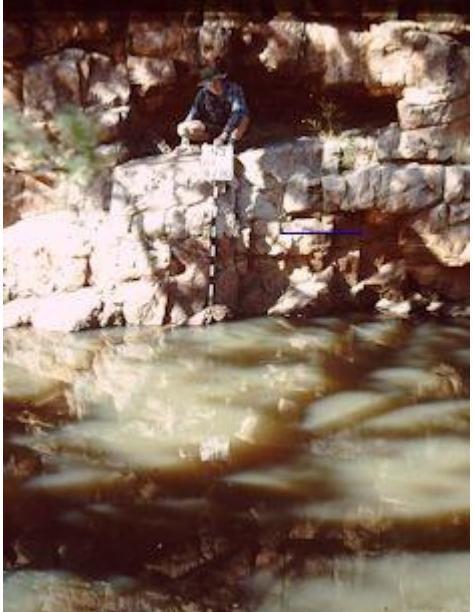
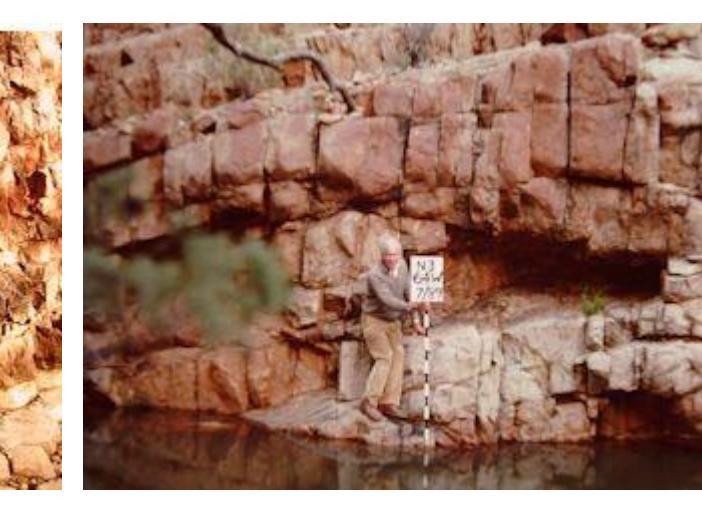
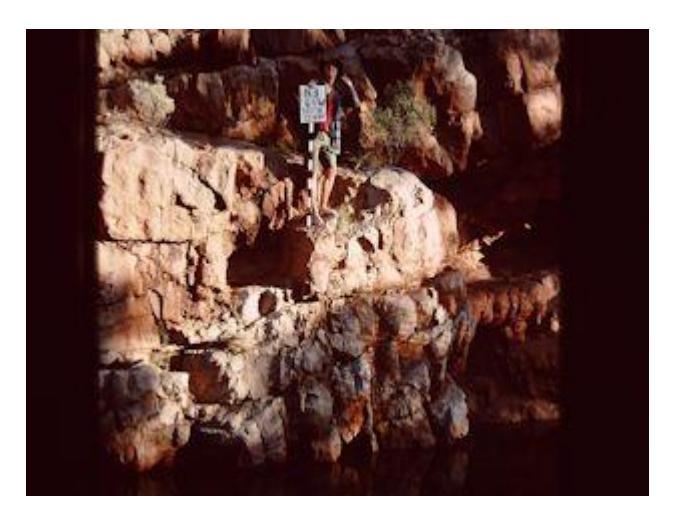
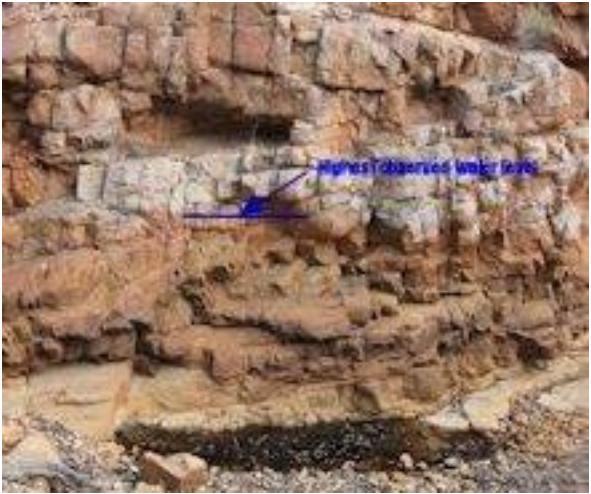
Site 64W: Sambot waterhole. The highest water level observed was in July 1990. In April 1990 Sambot had been empty (in the April 1990 quarter the rainfall recorded by the Plateau pluviometer was less than half the 22 year average. Data was not yet being collected at Sambot. By September 1990 the level had fallen substantially. The rainfall at Sambot in the July 1990 quarter was 250% of the 22 average and for the October 1990 quarter it was about 50% of average. In the next two quarters the rainfall was about 25% of average and then in the July 91 quarter rainfall was a bit above average. But Sambot was empty at July 1991. In the first three images on the next page there is a blue line that shows the change in water level from July 1990 to July 1991. The blue line is drawn at the same level on the rockface in all three images.

In 1989 rainfall in the April quarter was more than 400% of average but the water level in Sambot in April 1989 is less than (not much) for July 1990. The rainfall in the July quarter of 1989 was 200% of average and the July 1989 level is about the same as for July 1990. This suggests that the July 1990 level is a maximum level for the waterhole. The April 2009 image shows the difference between Sambot full and Sambot nearly empty.

April 2009 water depth is 35 cm

The images held of Sambot could be used to measure depth when full and estimate rate of loss of water. This would require measurements to be made of the distance above the bottom of the waterhole of certain features visible in many photographs.

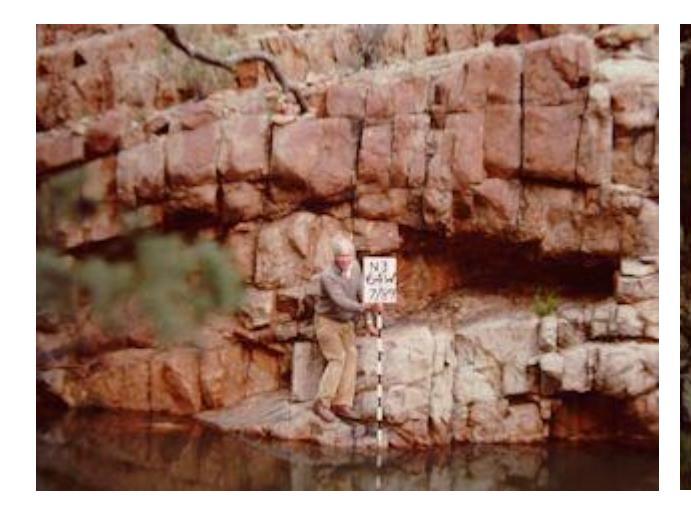
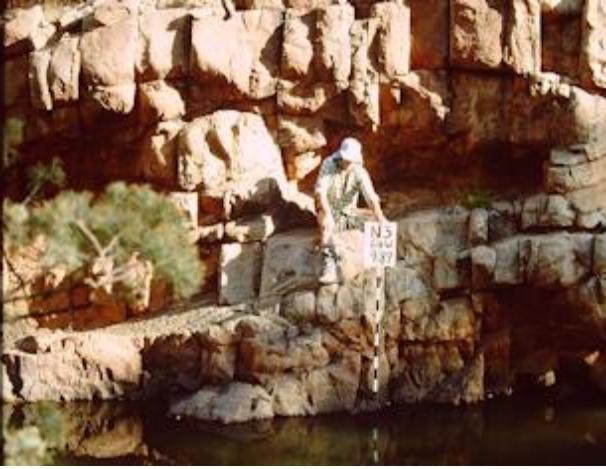
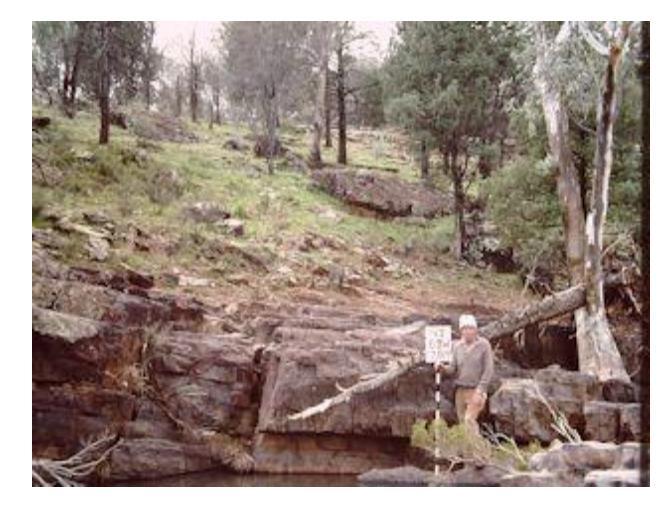
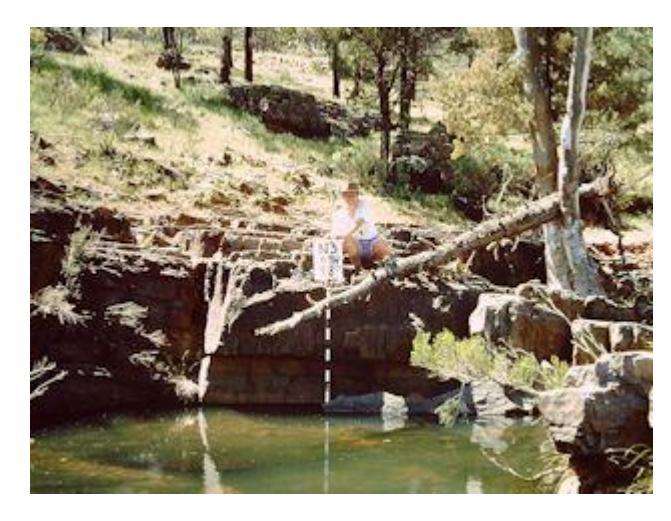
Site 69W: Wild Ass waterhole . Comparing levels in Wild Ass with Sambot for July and September 1989 we see that the level in Wild Ass dropped by much less than that in Sambot. This suggests that there is more loss from Sambot by leakage underground than from Wild Ass.

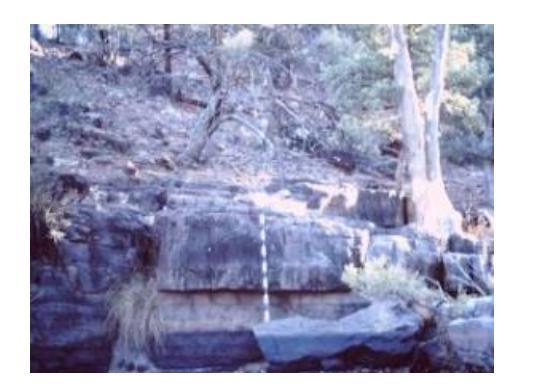
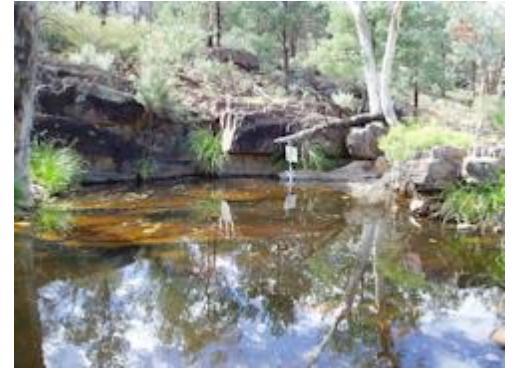
There is a Callitris lodged between two gum trunks at Wild Ass and it is hard to believe that water has ever flowed at a sufficiently high level in the creek to put it there. However, other explanations for how it got there seem just as unlikely. The photographic record shows that it took up its position sometime between February 1989 and July 1989. This is based on the photograph below which was apparently taken in February 1989 (but the date on the board is not readable). The rainfall at the Plateau Pluviometer in the April quarter for 1989 was 420% of the 22 year average. In absolute terms (mm of rainfall that fell) this was the highest quarterly rainfall seen from 1989 until 2011. Perhaps this was sufficient to fill the creek to a level

where the callitris was swept into place. Between October 2009 and April 2010 the callitris shifts position and is ends up resting at a lower position between the gum trunks. The rainfalls in the April 2010 and Jan 2010 quarters were 270% and 140% of average respectively.Perhaps this saw the creek level reach the callitris and refloat it then move it around so that it slipped lower as the water level dropped.

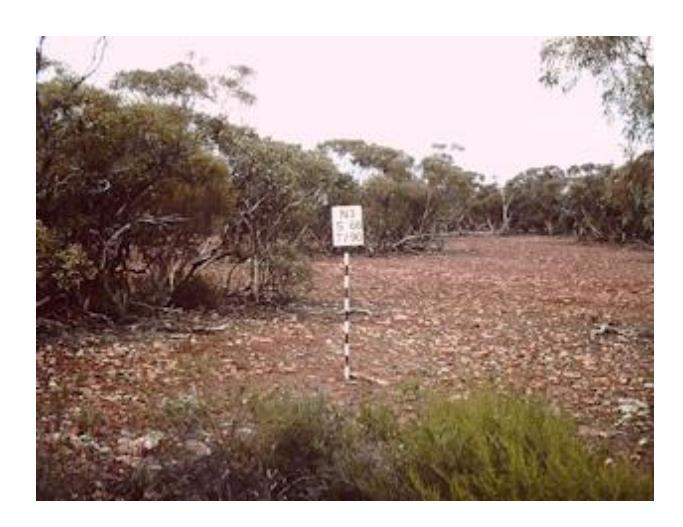
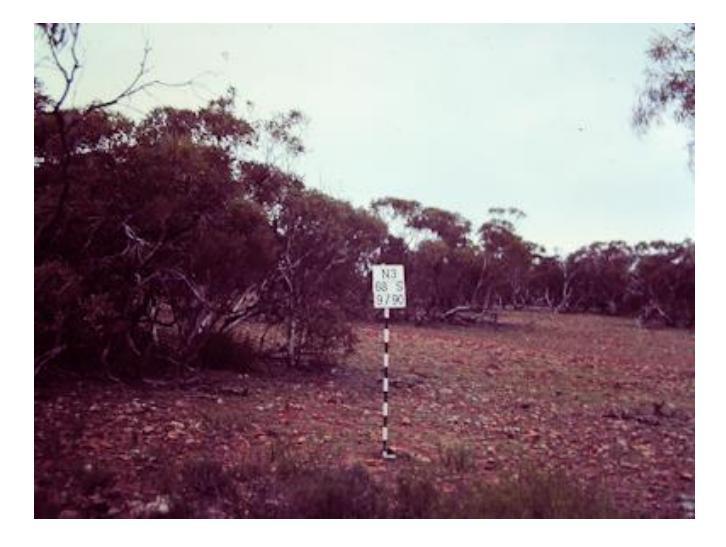
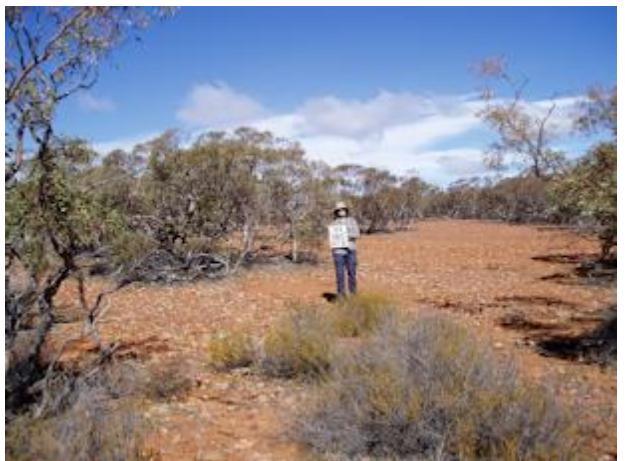
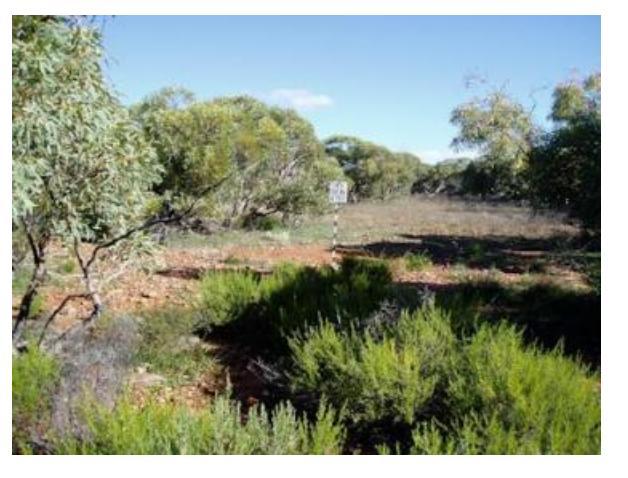
Site 68B. Mallee photopoint. There are 4 views of which the Southerly seems most informative. There is a substantial area of bare ground going off for some distance from the camera. In early photos there is low green growth evident that dies off and returns. But the 2010, 2011 images show striking levels of green growth much greater than seen in any other years. In 1990 the July quarter rainfall at the plateau was 250% of average. The july photograph shows some green bush near the camera and a green tinge on the ground going off into the distance. The bushes near the camera seem to have dried off by September but a green tinge is still evident on the ground going off into the distance.

Site 68B cont. In April 2008 the bushes close to the camera are very dry and there is no hint of green on the ground elsewhere. In April 2011 the bushes close to the camera look to be in better condition than at any other time during which photographs have been taken. There is also a relatively large amount of plant growth going off into the distance.

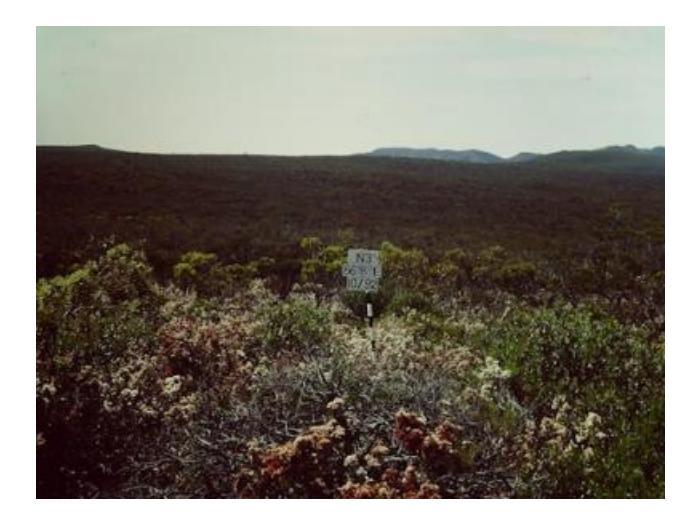
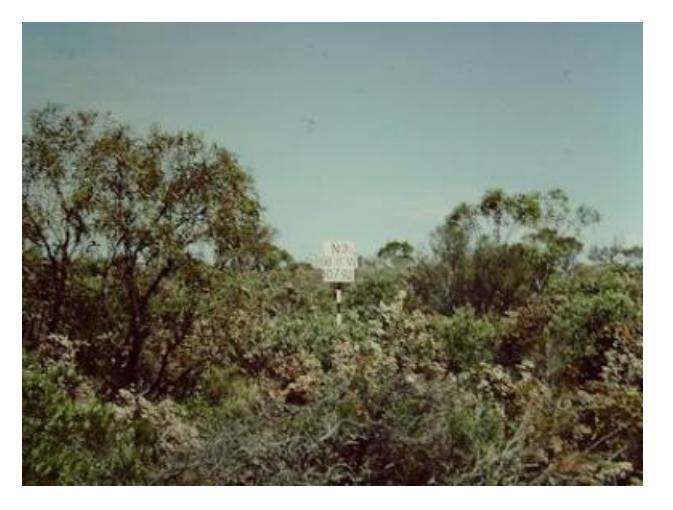
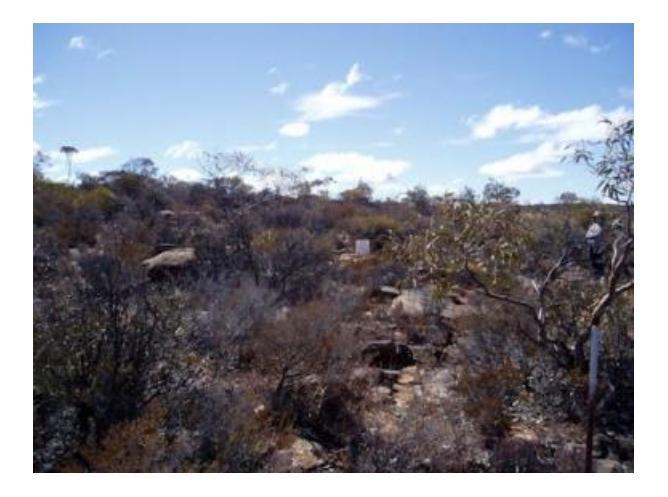
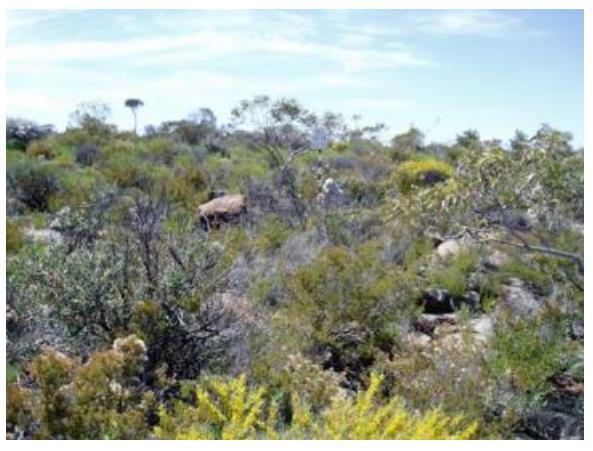
Site 66: Heath photopoint on the plateau. There are images for all four directions but only the Northerly images go beyond 2002. October 1992 easterly and westerly views show lots of flowers. Flowers are also in evidence in the October 2010 northerly image. The April 2008 northerly view shows the drying off of vegetation seen at other sites for this time. There are no images Easterly or Westerly images for 2007-2008 to compare with.

October 1992, Westerly view

April 2008, Northerly view

October 2010, Northerly view

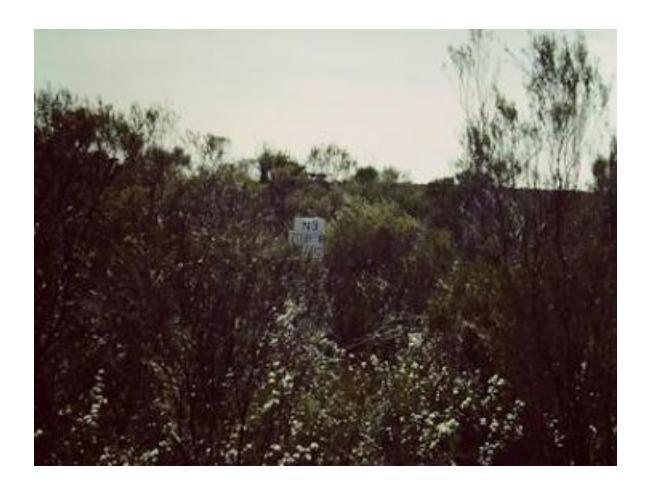
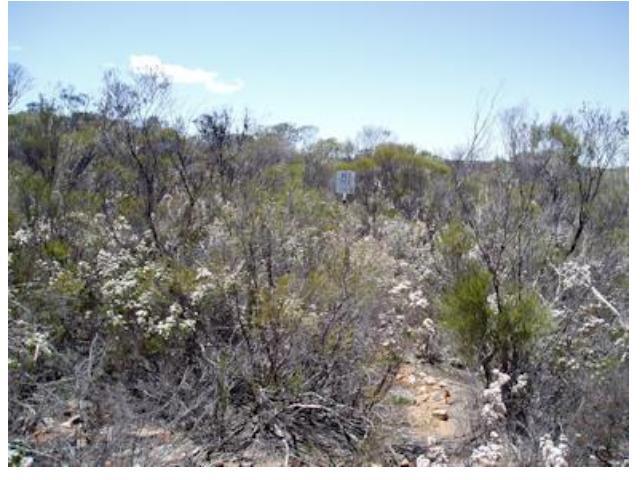
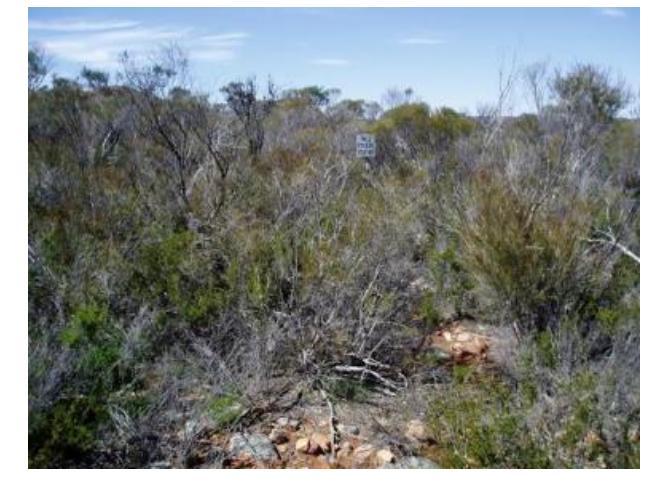
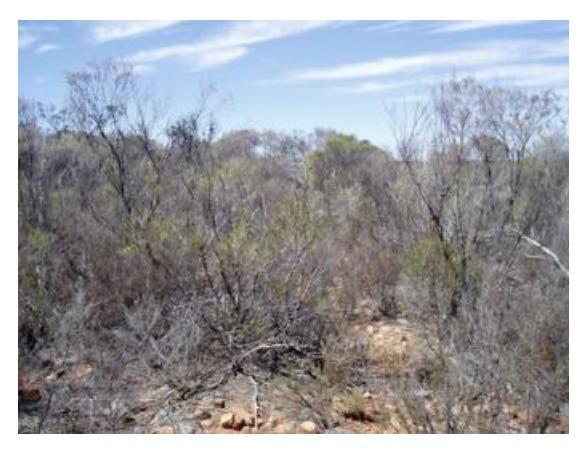
Site 70B: Melaleuca photopoint, plateau. White flowers are seen in the October 1992 and October 2009 images. It seems odd that they are not present in the October 2010 image because there was much more rain in the 2010 October quarter than in the October 2009 quarter. In the 2009 image the vegetation seems very dry but there are flowers. The October 2009 image seems to show the vegetation about as dried out as October 2008 which was a poor growth time for most sites. In October 2009 flowers were seen also at sites 65,66, 68, 69 and 74 but they were not as prominent as at site 70. Sites 71-73 showed no flowers for October 2009.

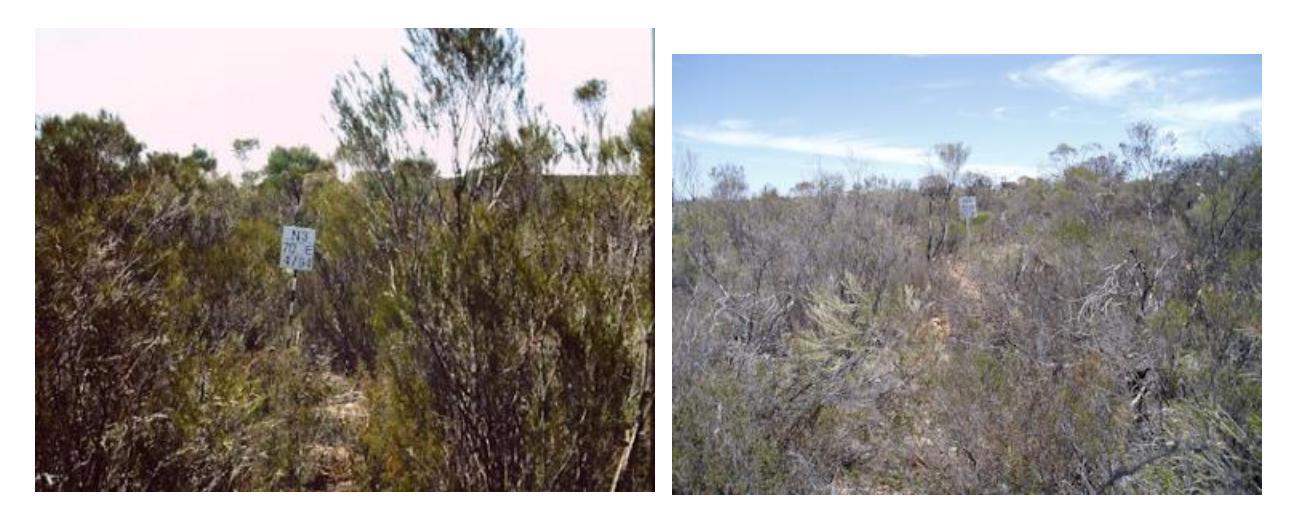
In the 2005 manual which I referred to while compiling this account there is reference to a track developing between the camera and marker point. People are asked to avoid walking through the site. This track can be seen in quite a few images before and after 2005. The small images below may not show this well.

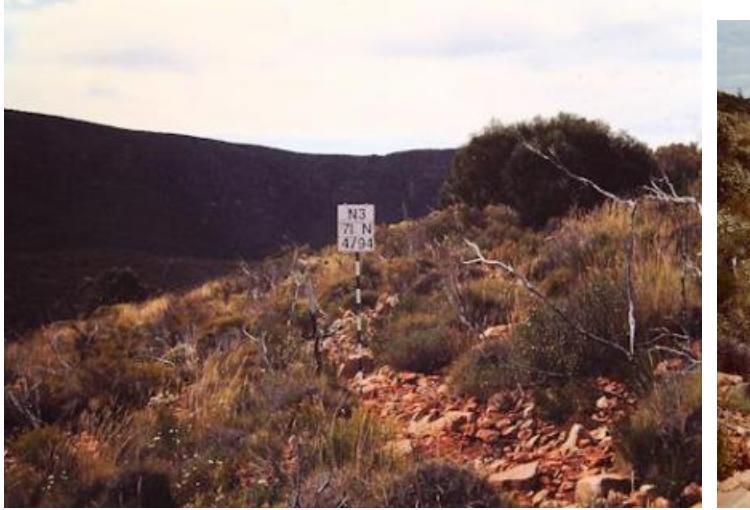
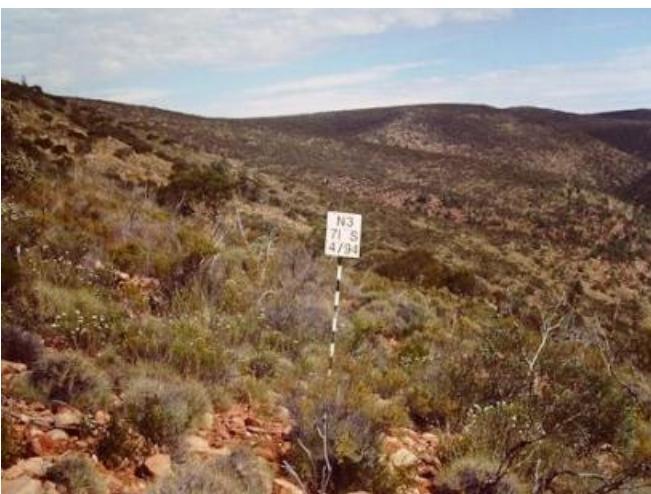
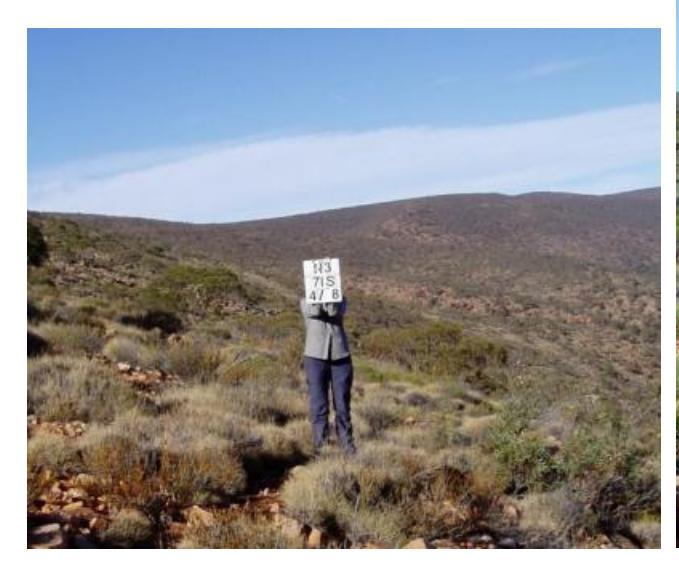
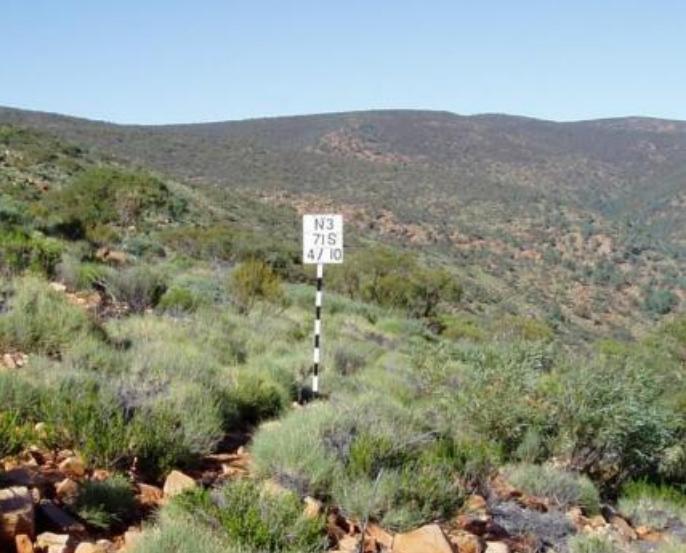
Site 71B: Burnt area, west slope of North Tusk Hill: there is a set of southerly images running from 1988 until 2011, northerly images running from 1989 until 2001 and a set of south-easterly images running from 2006 until 2011. There is a stardropper in the northerly images and this makes for a consistent field of view. In the southerly series the field of view is not as consistent.

There are significant (not lots) flowers in the April 1994 images but not in April 2010 image even though rainfall in the April 2010 quarter was much higher and the vegetation much more lush. In the April 2008 image there is the obvious drying off seen elsewhere at that time.

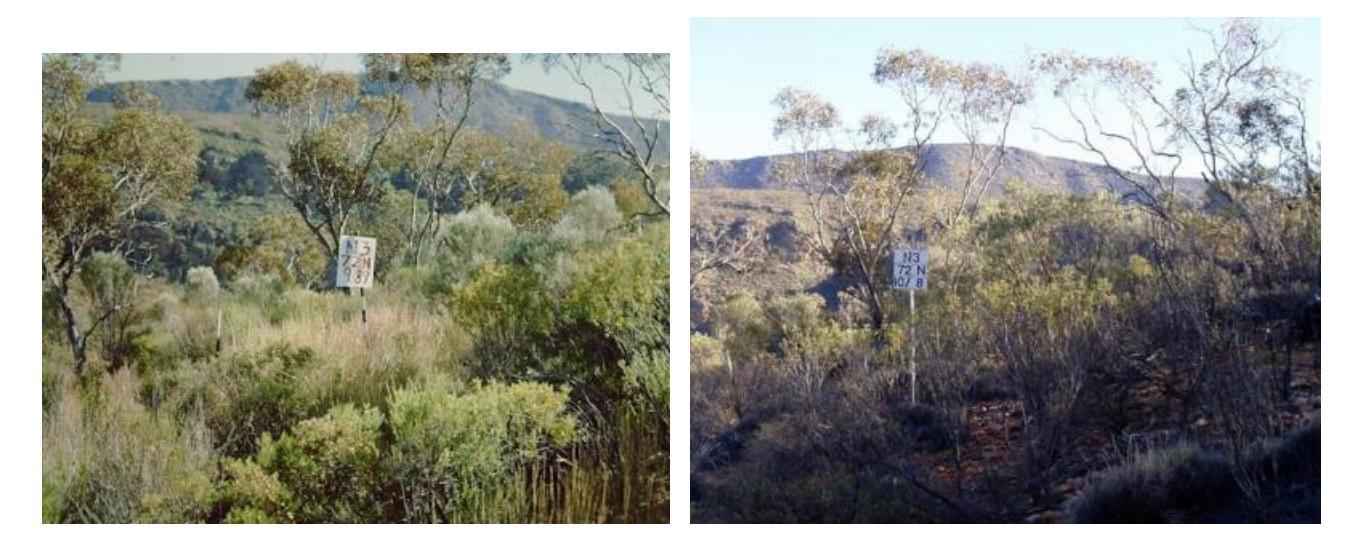
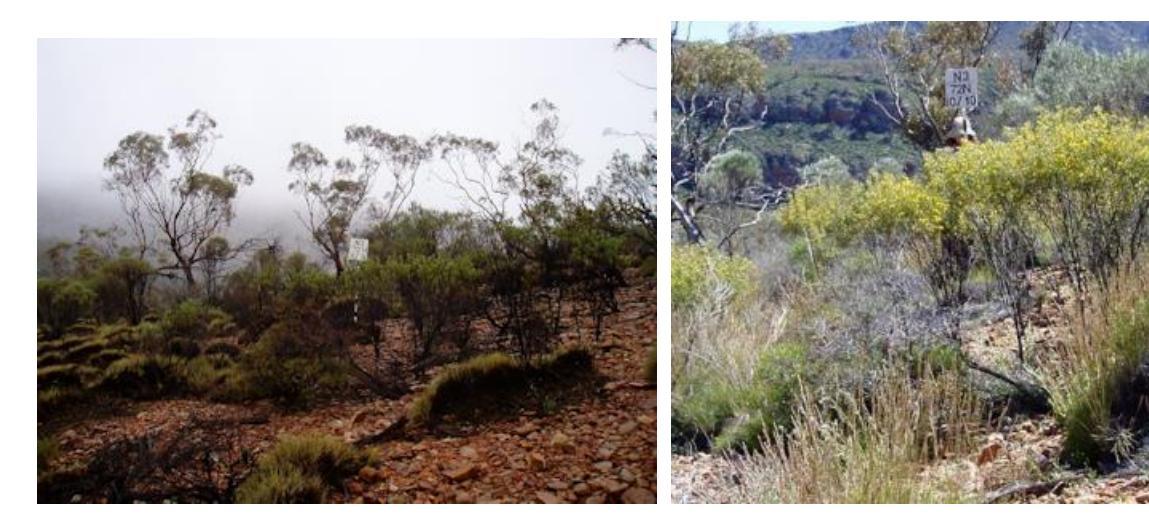
Site 72B: Burnt area, west slope of North Tusk Hill lower elevation than site 71: there is a stardropper in the northerly view which makes for consistent field of view. Yellow flowers and thick growth are seen in the northerly view for September 1989. October 2008 there is substantial dry-off and thinning out. The April 2009 image shows recovery and the October 2010 image shows a large display of yellow flowers but vegetation remains thinned out compared to September 1989
